2008 ANNUAL REPORT

CANYON FUEL COMPANY, LLC SUFCO MINE ACT/041/002

Re: 2008 Annual Report for Canyon Fuel Company LLC, SUFCO Mine
C/041/002, Sevier County, Utah

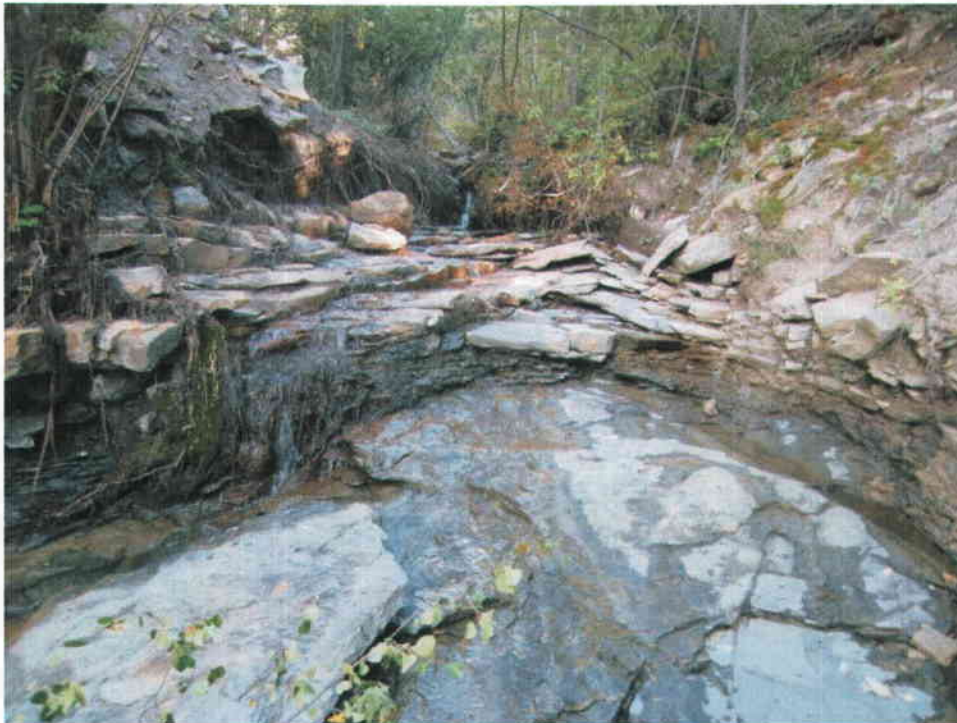
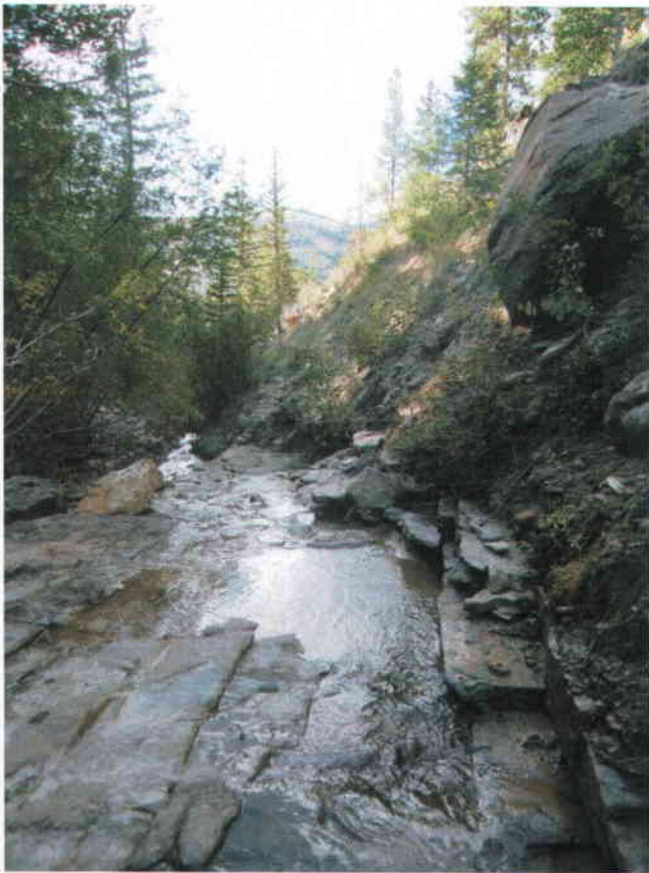
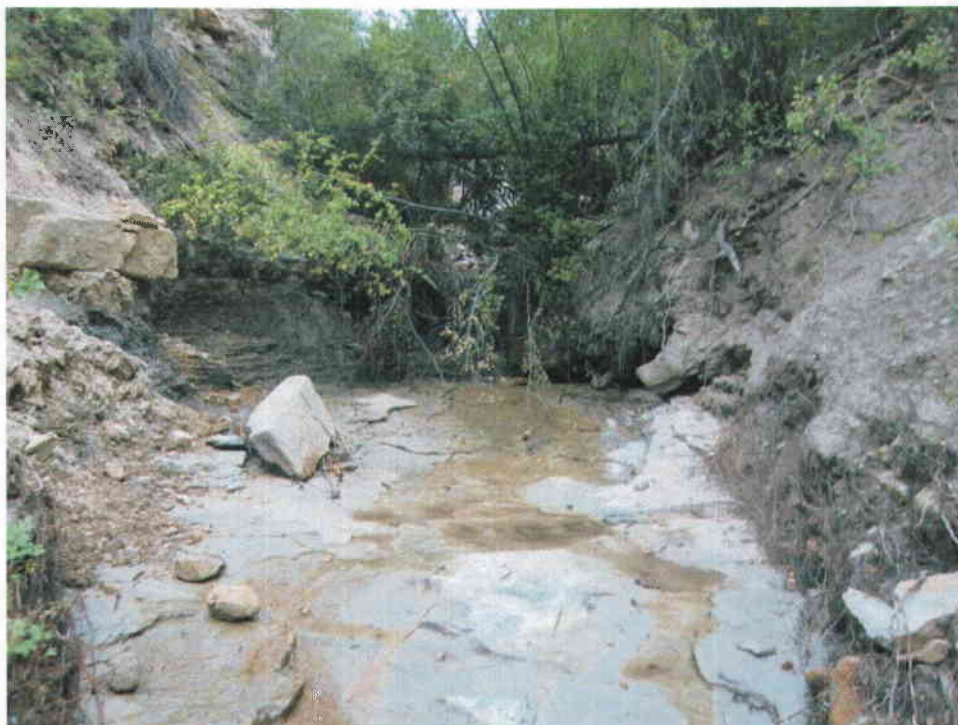
Stream channel at EFB-8

Stream channel below EFB-11

Figure 10 Photographs of the East Fork stream channel after the 19 July 2006 torrential thunderstorm runoff event.

Stream channel near EFB-11A

On 19 July 2006, a torrential thunderstorm event occurred in the East Fork drainage. On that date, precipitation measured at Sufco's East Fork Weather Station located adjacent to EFB-2 totaled 1.17 inches in a two-hour period. Based on field observations subsequent to the precipitation event, it was apparent that the discharge was focused in the North Water Canyon area and that a surface-water discharge several feet deep rushed down North Water Canyon and subsequently down the main stem of the East Fork to the confluence with the main fork of Box Canyon. There was no indication of a torrential flood of water in either the East Fork above EFB-6 or in the main fork of Box Canyon above Pines 407. Upon inspection of the East Fork drainage below EFB-6 subsequent to the storm, it was readily apparent that substantial changes to the stream morphology in the stream had occurred. In many locations, alluvial and colluvial sediments and associated vegetation underlying and directly adjacent to the stream were eroded away, leaving a bare, exposed bedrock channel substrate. Additionally, in some areas where loose or highly weathered bedrock was present in the stream substrate, this material was removed by the torrential stream flow leaving significantly altered stream channel configuration. Photographs of the East Fork stream channel after the torrential precipitation event are shown in Figure 10. An additional torrential precipitation event was recorded at the East Fork Weather Station on 5 October 2006, with a measured rainfall of 1.79 inches in a 24-hour period.
